Structural Inspection Report

Glebe Road Overpass

Submission Date: 13th September 2023

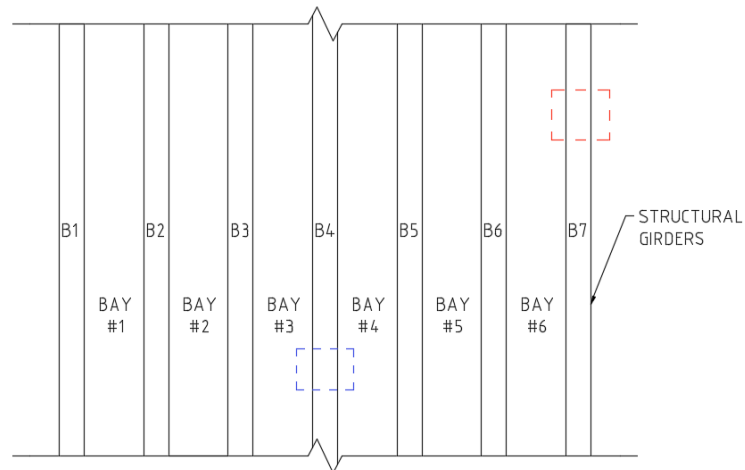
Figure 1- Bridge notation reference

- b. There is a significant crack along a small section of the prestressed concrete flange as shown in Photograph 7 and 8 in Appendix A. The approximate location of the crack is identified in Figure 1.

- b. There are two areas where there appears to be pitting corrosion, as shown in Photograph 9 and 10 in Appendix A. The approximate location of the corrosion is shown in Figure 1.

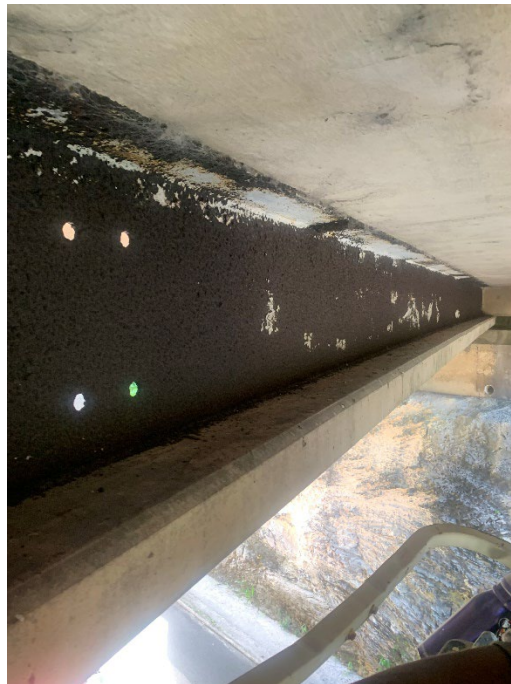
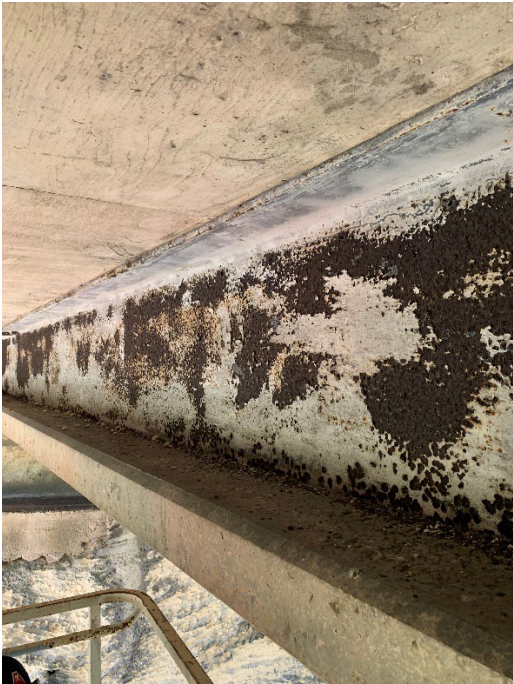
- B1
 - A significant proportion of the galvanizing system has failed, with corrosion of the steel surface visible. An example of this is shown in Photograph 2 and 3 in Appendix A.
 - There is one location where holes have been drilled through the web. There is severe corrosion around the perimeter of the bottom two holes, as shown in Photograph 4 in Appendix A.
 - The prestressed concrete flange appears to be in good condition. An example of this is shown in Photograph 5 and 6 in Appendix A.
- B2
 - A significant proportion of the galvanizing system has failed, with corrosion of the steel surface visible. An example of this is shown in Photograph 2 and 3 in Appendix A.
 - The prestressed concrete flange appears to be in good condition. An example of this is shown in Photograph 5 and 6 in Appendix A.
- B3

1. The original protective coating system has failed, causing the steel beams to corrode. Although the corrosion did not appear to be severe, it is unclear how much of the original steel section remains intact.
2. There are localized areas where holes have been drilled through the web. In some of these locations, the section of steel to the perimeter of the hole has severely corroded. The risk is that as the severity of the corrosion worsens, the holes could potentially merge, to form one larger hole.
3. It is not clear what has caused the crack along the prestressed concrete encasement in beam B4. However, the crack appears to be localized and there are no other defects along the length of the girder to indicate that the crack is affecting the structural capacity of the member.

Photograph 2 – Example of the failed protective coating

Photograph 3 – Example of the failed protective coating

1. The beams should be cleaned of all corrosion and a new protective paint system applied to ensure the durability of the existing structure. The new protective coating should be specified to provide life to first maintenance of minimum 15 years.
2. The thickness of the original metal should be surveyed, and the load capacity of the bridge structure assessed.
3. Further investigation of the crack along the prestressed concrete encasement on beam B4 should be carried out to determine what remedial works may, or may not, be required.

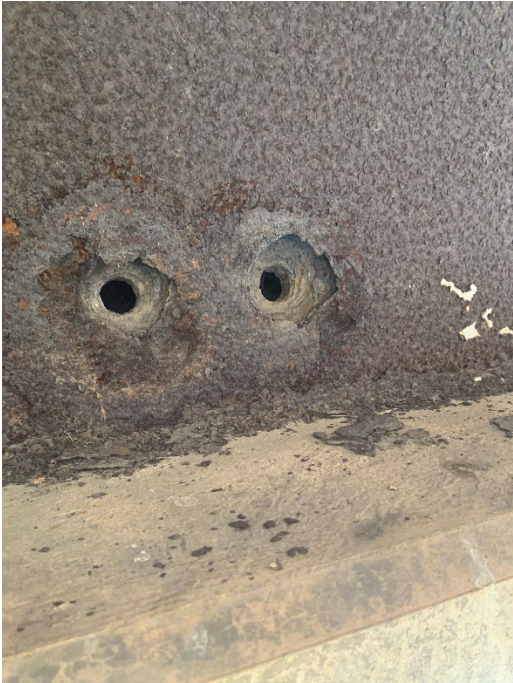
Photograph 4 – Corrosion of holes through Beam B1

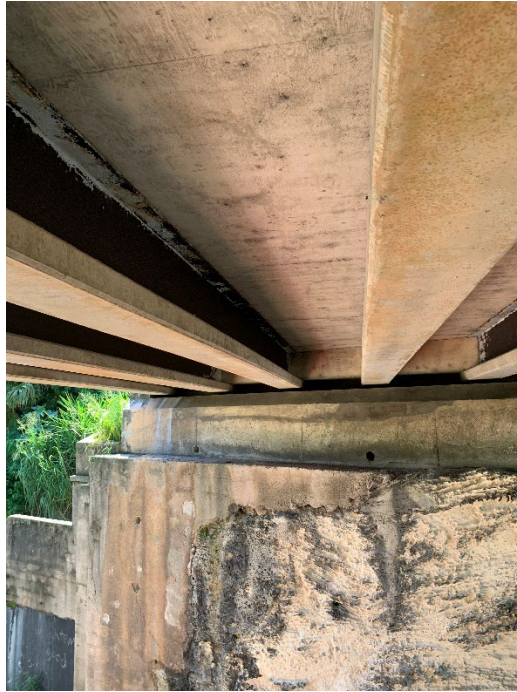
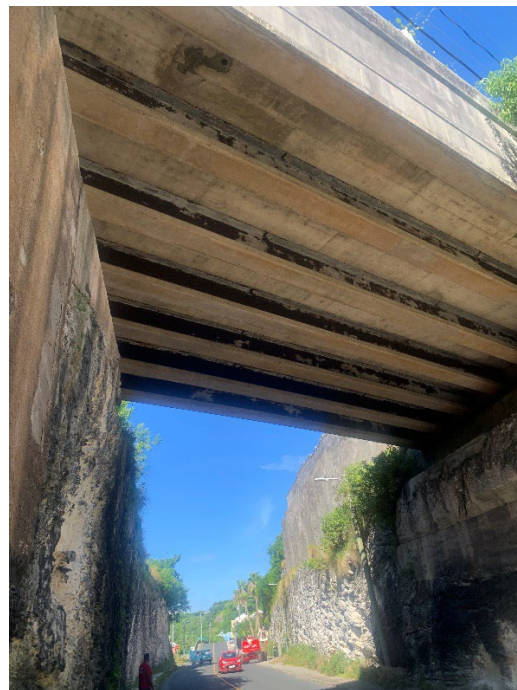
- b. The prestressed concrete flange appears to be in good condition. An example of this is shown in Photograph 5 and 6 in Appendix A.
4. B4
- a. A significant proportion of the galvanizing system has failed, with corrosion of the steel surface visible. An example of this is shown in Photograph 2 and 3 in Appendix A.

Photograph 5 – Example of prestressed concrete encasement in good condition

Photograph 6 – Example of prestressed concrete encasement in good condition

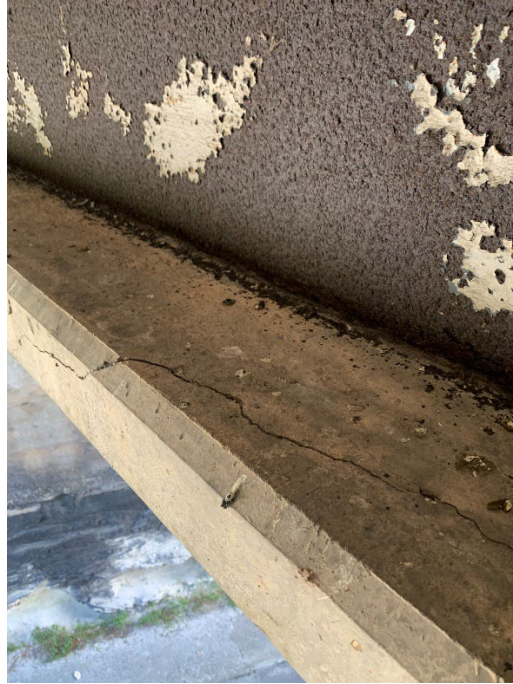
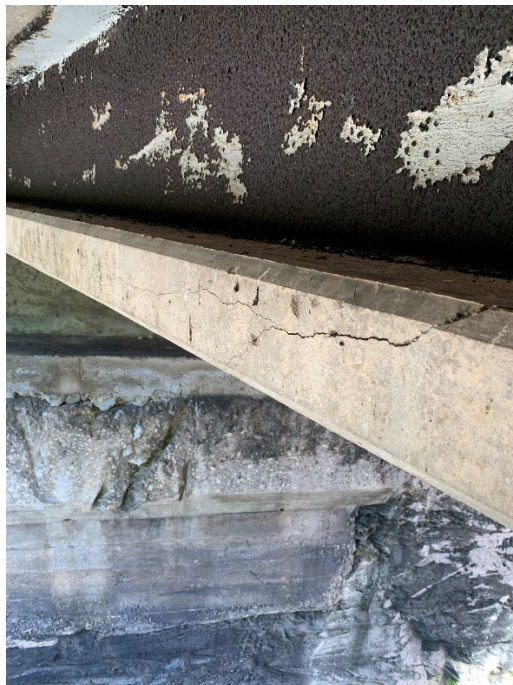
Photograph 7 – Localized crack in Beam B4 prestressed concrete encasement

Photograph 8 – Localized crack in Beam B4 prestressed concrete encasement

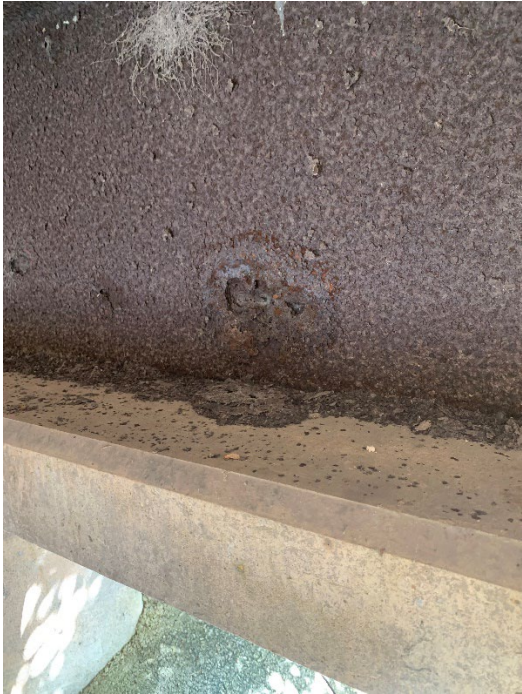
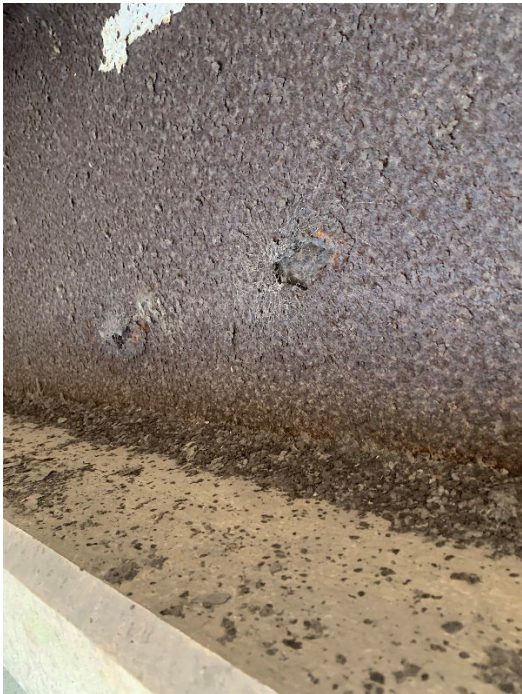
Photograph 9 – Localized evidence of corrosion pitting in Beam B7

Photograph 10 – Localized evidence of corrosion pitting in Beam B7

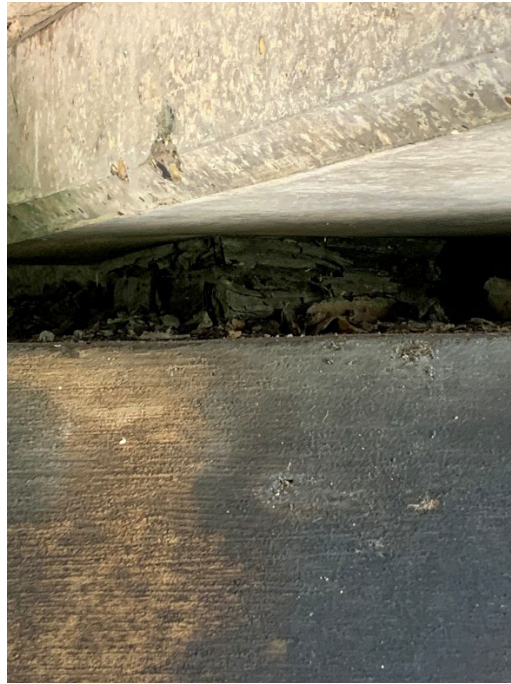
1. The overall condition of the bearings appears to be poor.
2. The bearings appeared to be severely corroded, which has resulted in the concrete upstand detaching from the steel bearing. An example of the corrosion is shown in

Photograph 11 in Appendix A. Video (MOV) files IMG_8404, IMG_8405, IMG_8406 and IMG_8481 showing the extent of the corrosion are included in the data pack issued with this report.

1. Due to the space available, it is difficult to get a close inspection of the bearings. They are also not visible on all four sides, therefore it is difficult to provide a comprehensive assessment of their condition. However, based on what is visible, there is significant corrosion of the bearings and localized degradation of the concrete plinths on which the bearings sit.
2. Given the condition of the bearings, it is possible that potential issues could arise in the future. This is a particular risk as there appears to be no protection system in place to prevent or slow the ongoing degradation.

Photograph 11 – Example of severe corrosion of the bearings

1. Due to the severe corrosion of the bearings, consideration should be given to full replacement of the bearings.

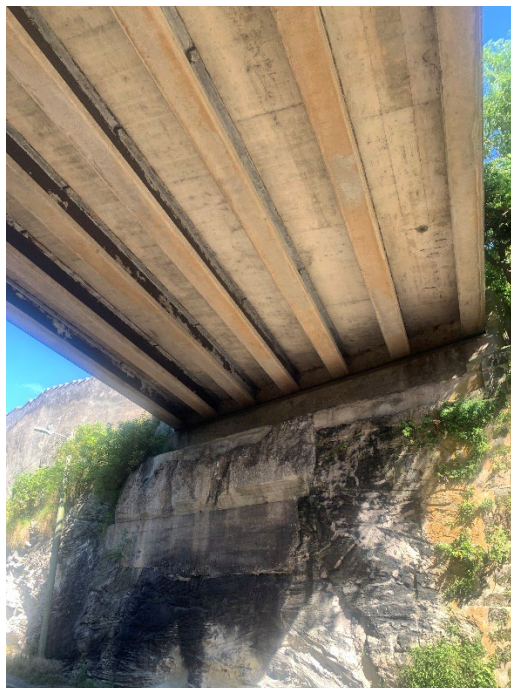
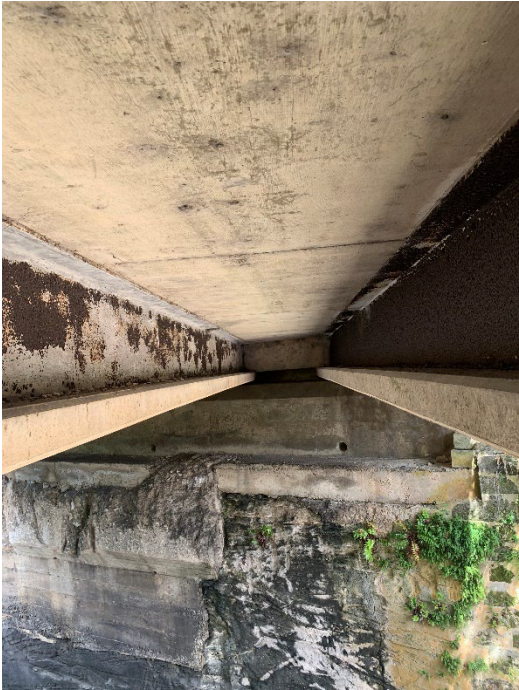
1. The overall condition of the concrete decking appears to be fair, as shown in Photographs 12 and 13.
2. There are localized areas where the concrete has spalled due to corroded reinforcement, with the bottom reinforcement exposed. Examples of this are shown in Photograph 14 and 15 in Appendix A.
3. There are localized areas where the concrete has spalled, but it is still attached to the soffit of the bridge deck. An example of this is shown in Photograph 16 and 17 in Appendix A.

Photograph 12 – Overview of the bridge deck soffit

Photograph 13 – Bridge deck soffit

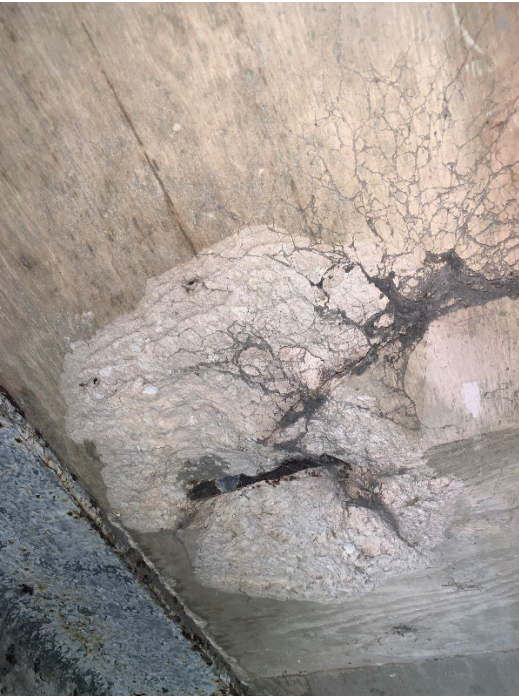
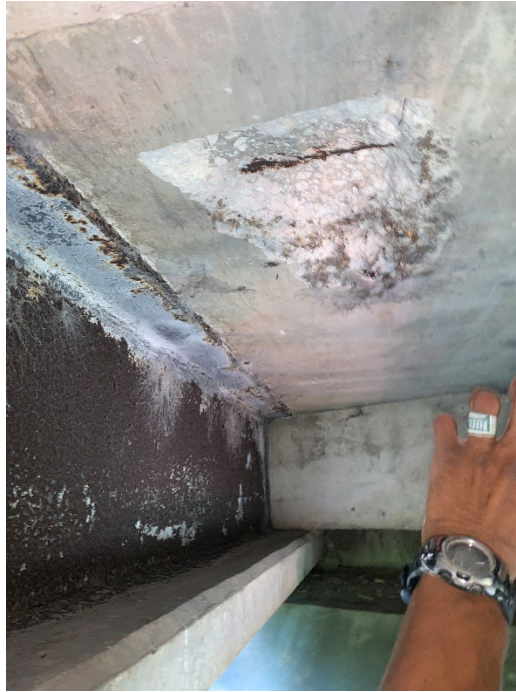
1. The localized areas where the reinforcement is exposed could lead to further corrosion of the reinforcement, which could impact the capacity of the deck.
2. The localized areas where the reinforcement is exposed could lead to further spalling as the adjacent section of reinforcement could corrode. This is a concern as falling debris represents a high risk to vehicles passing beneath the overpass.
3. There are some locations where the concrete has spalled but has not fallen off to expose the reinforcement. This is a concern as the loose debris will at some point fall from the soffit, which represents a high risk to vehicles passing beneath the overpass.

Photograph 14 – Example of localized spalling to bridge deck soffit

Photograph 15 – Example of localized spalling to bridge deck soffit

1. In the localized areas where the concrete has spalled, a concrete repair mortar should be applied to reinstate the soffit of the deck and protect the reinforcement from corrosion.
2. Given the high risk associated with falling debris, it would be prudent to use a rebound hammer to test for areas of the soffit where the concrete is unsound. Any areas of unsound concrete should be broken out, and a concrete repair mortar applied.

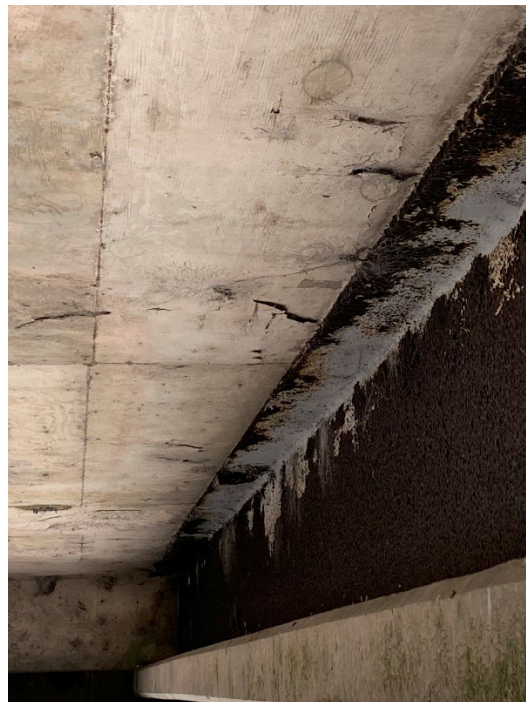
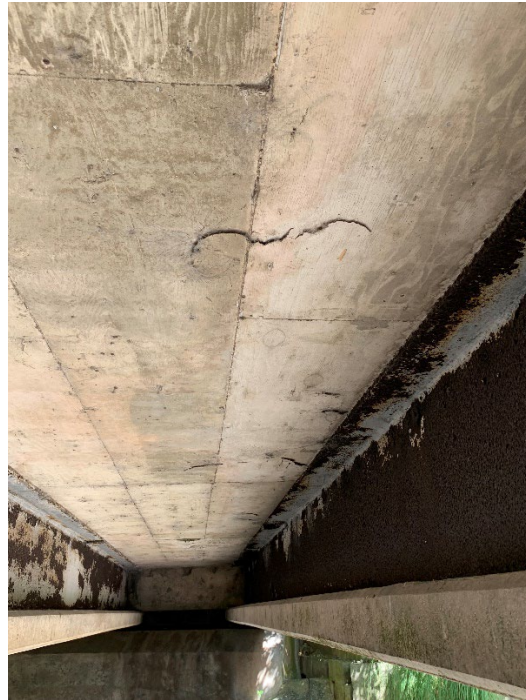
Photograph 16 – Example of localized spalling with concrete still attached to soffit

Photograph 17 – Example of localized spalling with concrete still attached to soffit

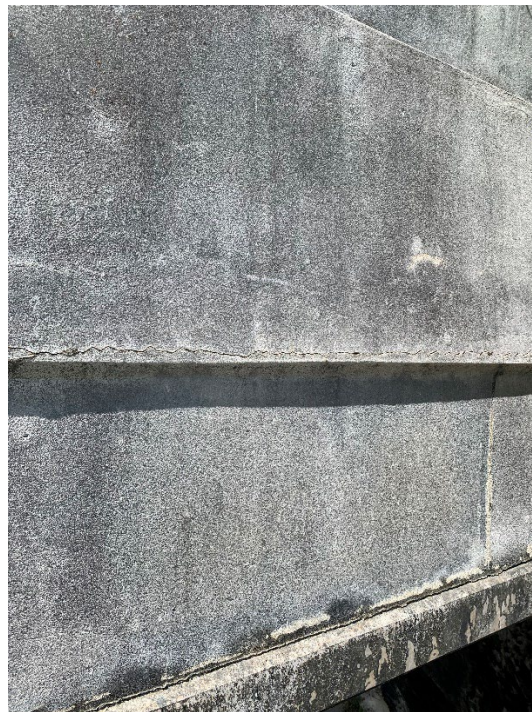
1. The condition of the parapet appears to be good to fair.
2. There is a horizontal crack within the render along the outside face of the eastern parapet, as shown in Photograph 18 in Appendix A.

1. The crack along the eastern face of the parapet appears to be superficial, therefore it does not appear to be a structural issue.

Photograph 18 – Crack along the eastern parapet
