**Addendum**

**Interior and Exterior Painting, Gibbs Hill Lighthouse**

Addendum No, **4 – Issued September 18, 2026**

**Re: Gibbs Hill Lighthouse, Southampton – Gallery Platform  
Structural Condition Assessment Report**

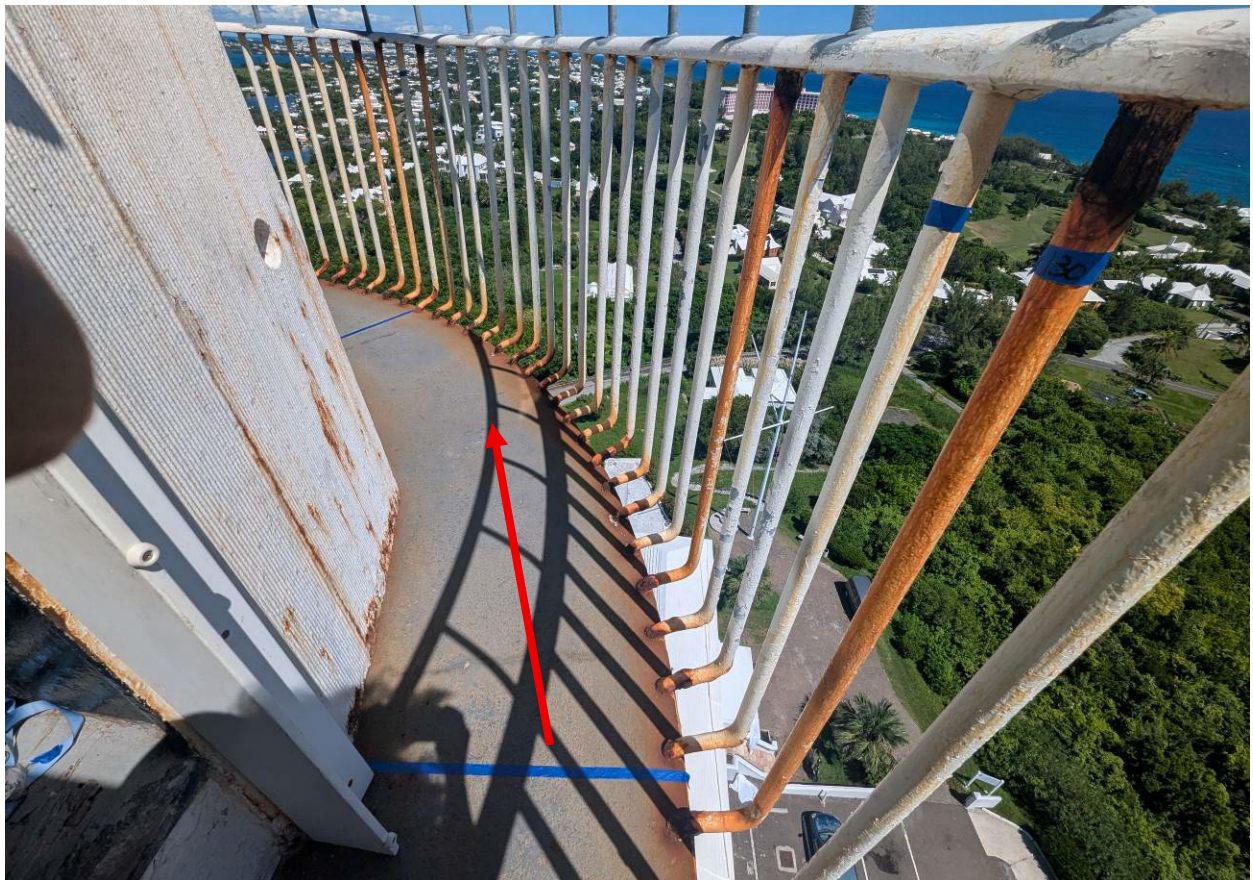
Photograph 4: Lower railings Section 1 (Bars 001 to 020) commencing from platform entry door

4. Table 1 has been inserted (at the end of this report) to detail the condition of the lower gallery railings based on our visual assessment. The railings were categorized into sections for the purposes of the assessment and referencing of photos. The sections commence from the platform entry door and are numbered sequentially in a counterclockwise direction around the platform, as shown in Photograph 4.

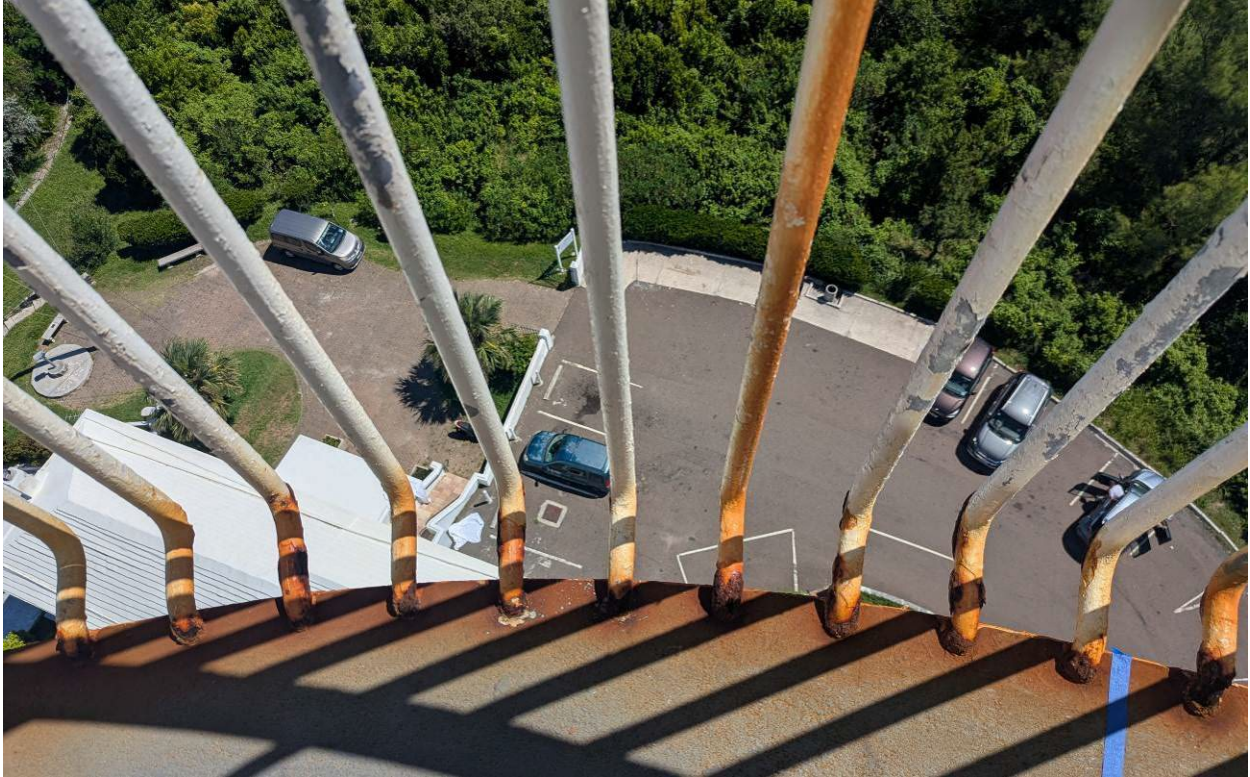
Photograph 5: Lower railings base in Section 1

6. Severe corrosion was observed at the base of the railings and there appears to be section loss visible at the base of the vertical bars including the horizontal section which extends beyond the platform edge.

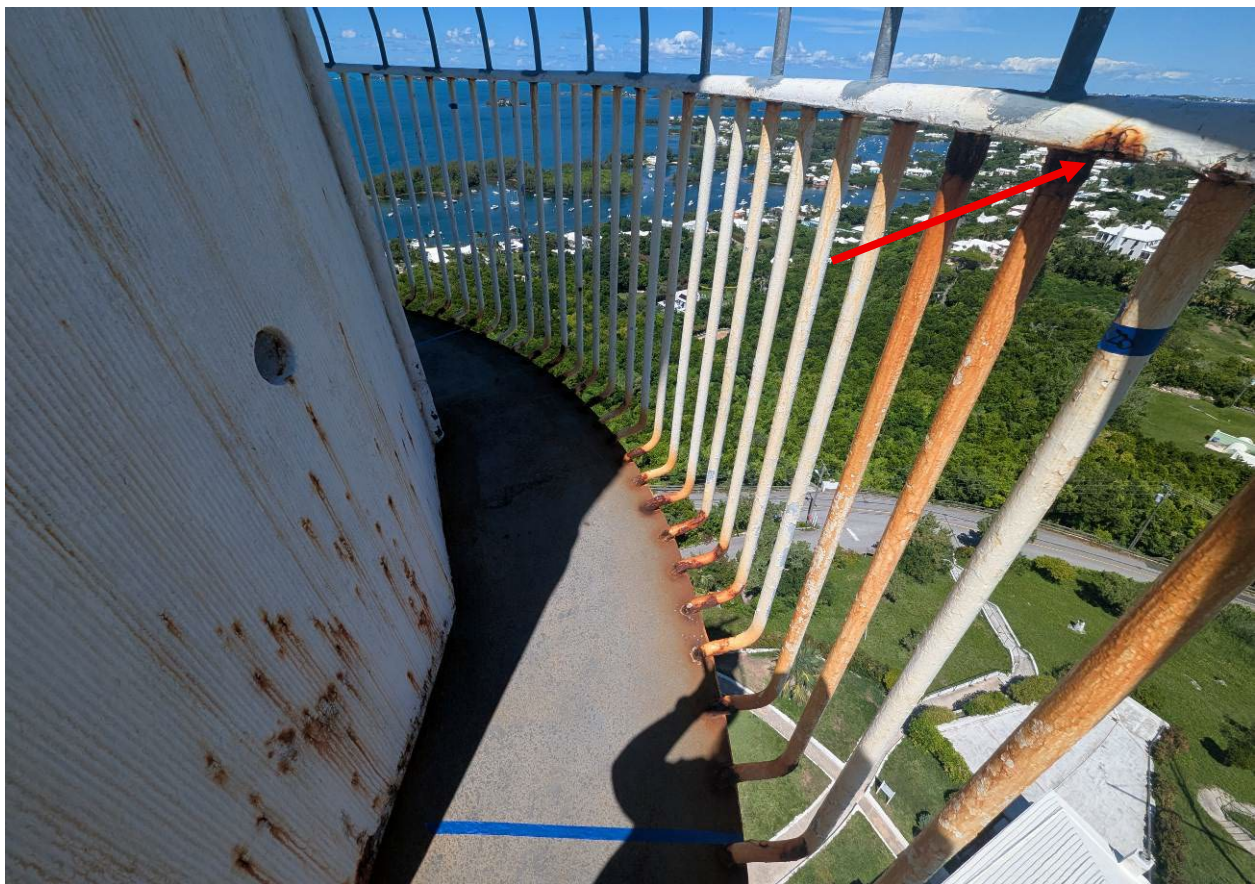
7. The intermediate top-rail exhibits localized coating deterioration, discoloration and corrosion, mainly concentrated around connections with the lower vertical members. The most notable deterioration was recorded between bars 20 and 21 and 86 to 87; this is marked on the photographs at the end of this report.

Photograph 8: Lower railings in Section 2 (Bars 021 to 040)  
Intermediate top-rail between bars 20 to 21 exhibits corrosion

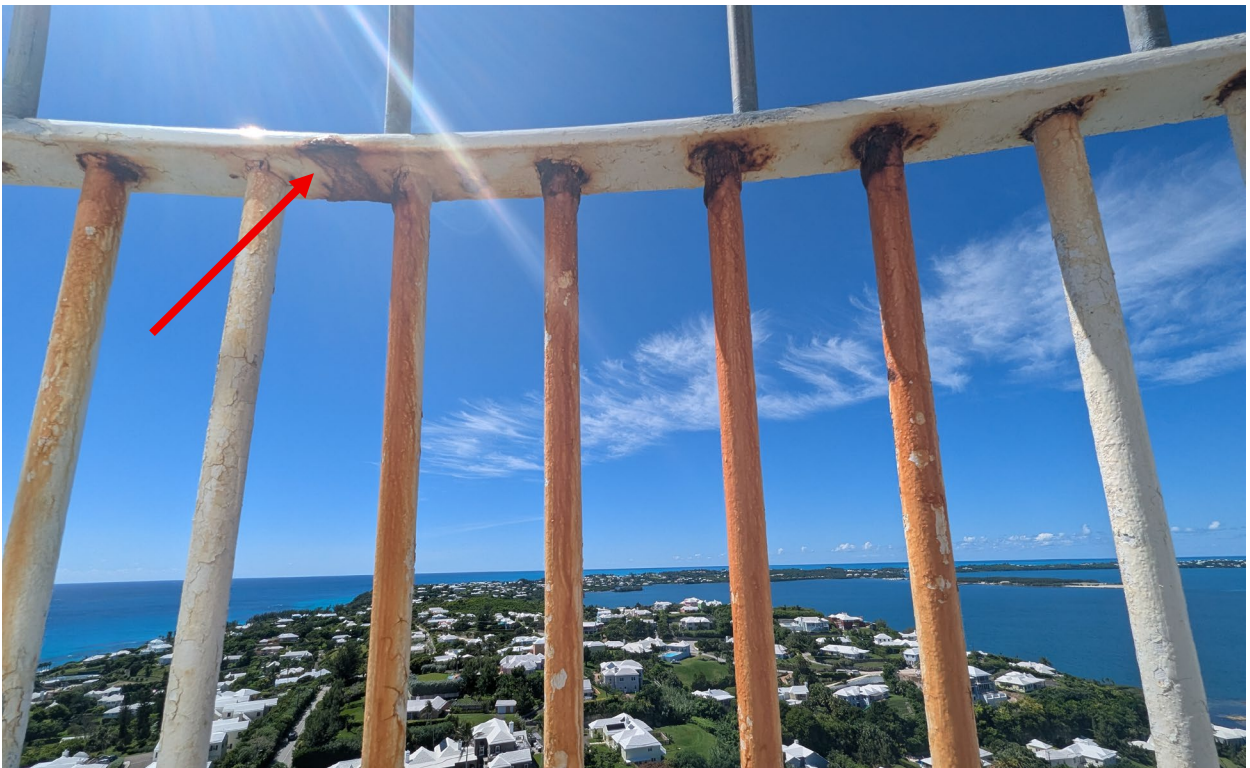
Photograph 18: Lower railings connection to intermediate rail in Section 5 (Bars 082-088)  
Intermediate top-rail between bars 86 to 87 exhibits corrosion

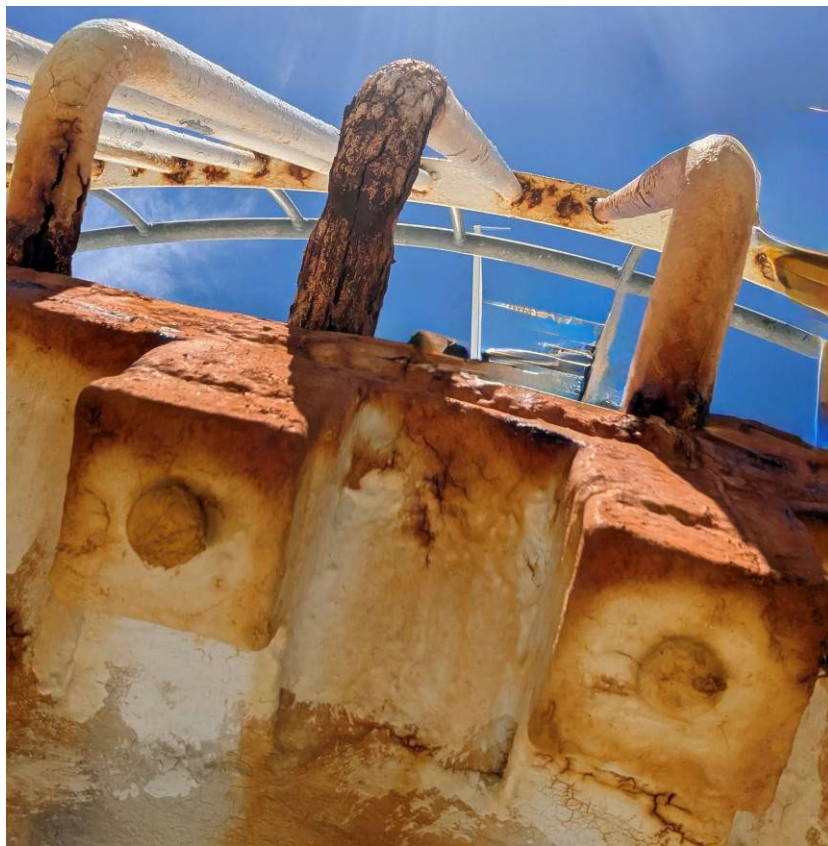
3. The lower railings appear to be bolted to the underside of the platform structure based on visual assessment of the external view of the lighthouse. The bolts were observed to be covered with multiple layers of coating, which are likely to make removal difficult.

Photographing the underside of the platform section was difficult, a single example is included at the end of this report as Photograph 21.

Photograph 21: Example of bolted connection at underside of platform and corroded bars (Section 6)

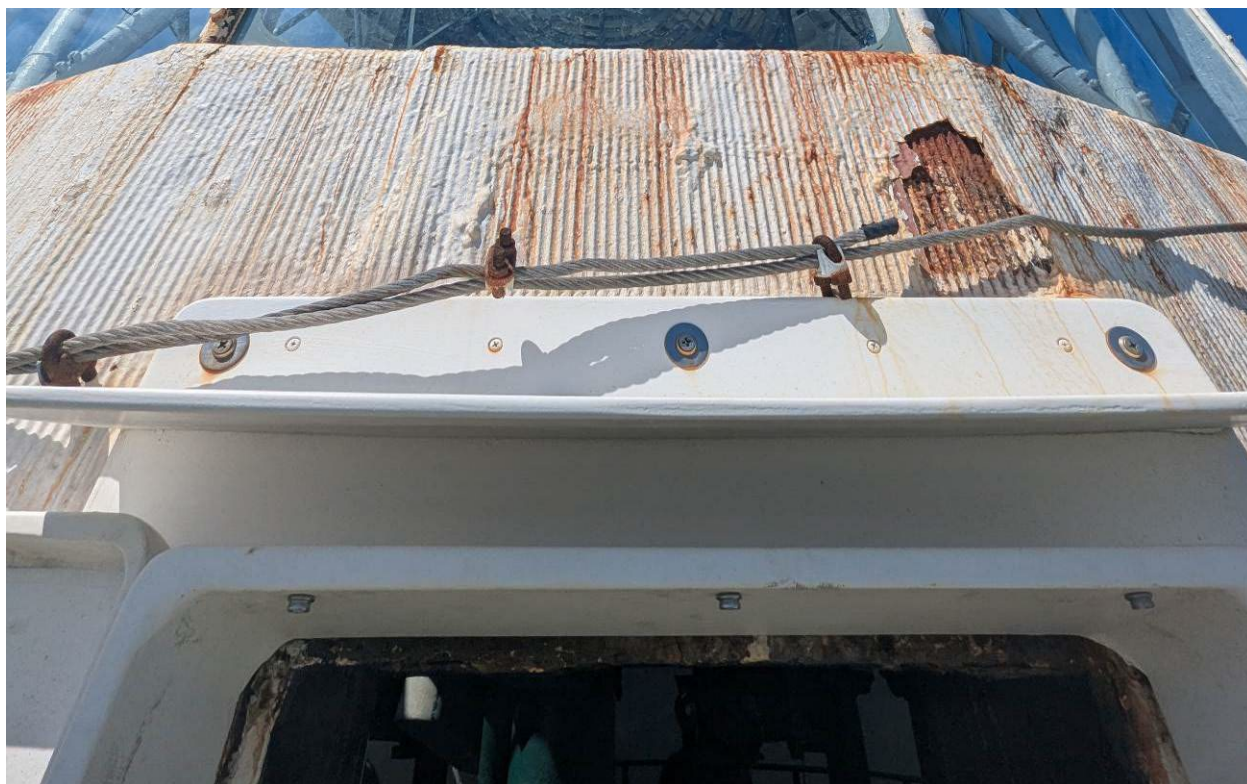
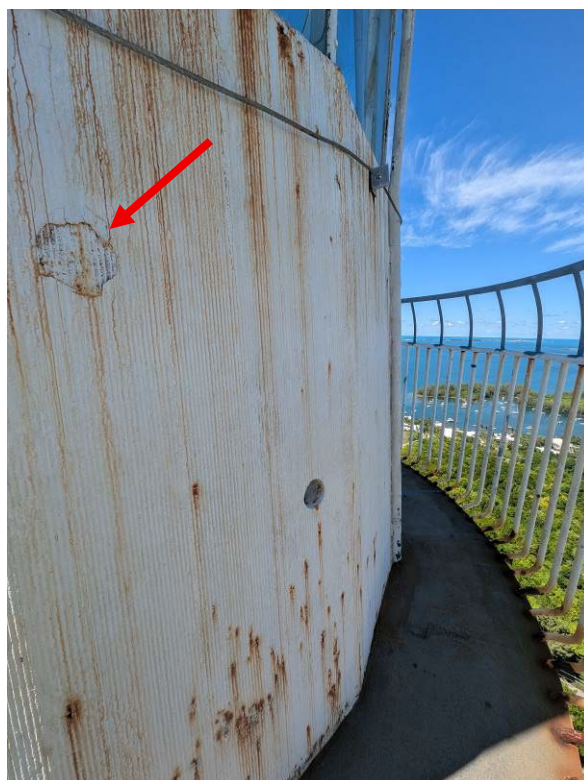
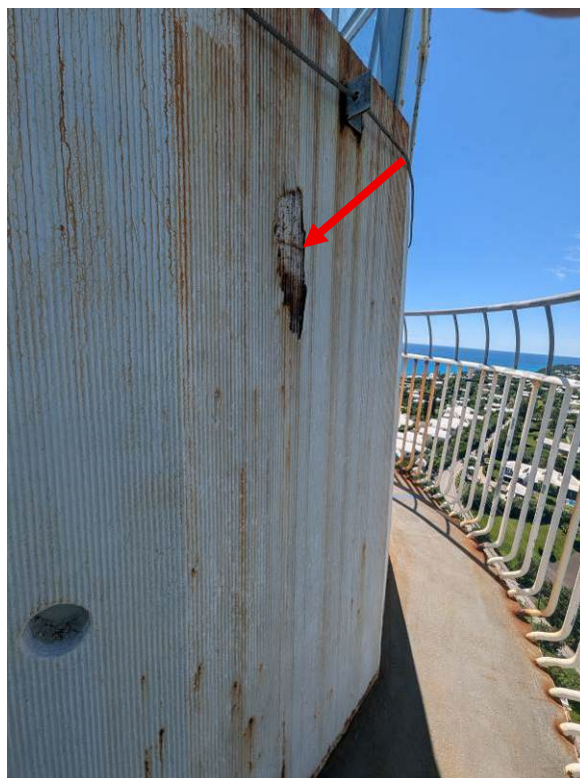
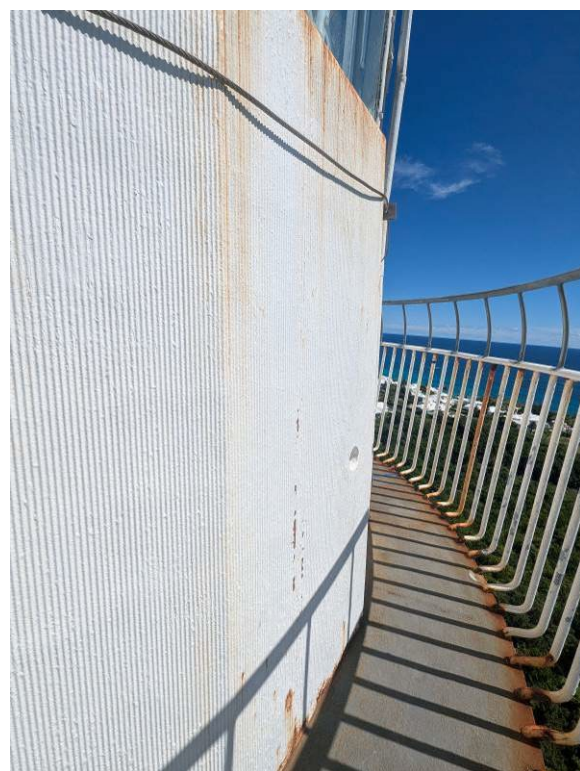
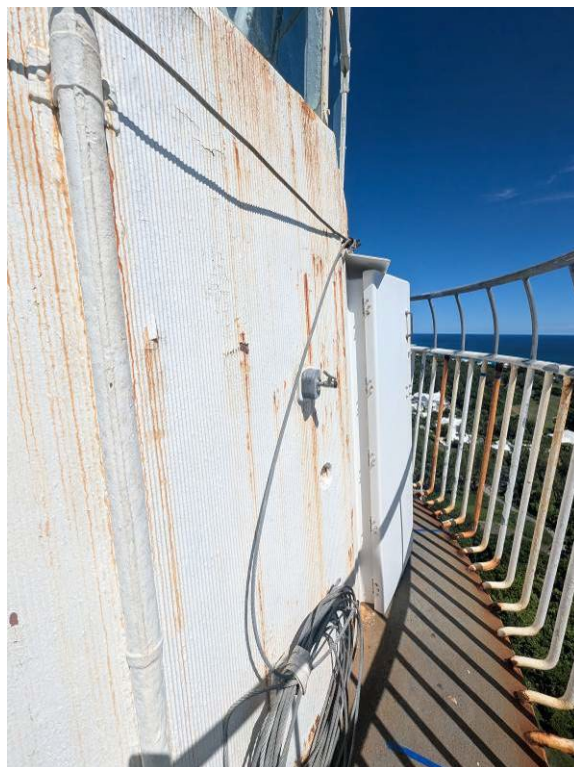
11. The cast iron façade exhibits signs of deterioration. The coating is weathered with widespread rust staining, blistering and peeling coating/paint. In some areas corrosion appears to have propagated beneath the coating resulting in delamination of the coating.

- d. Based on the visual assessment it would appear that the deterioration to the cast iron façade is superficial. Areas of cracked, loose or delaminated material should be carefully opened up to expose a sound substrate and to determine the extent of corrosion and any associated section loss. It is considered likely that localized repairs may be required in these areas.
